# Remedial Alternatives Evaluation

## Castlebridge Properties, LLC Property

200/280 National Avenue  
Spartanburg, South Carolina  
VCC 07-5712-RP

Terracon Project No. 86117104

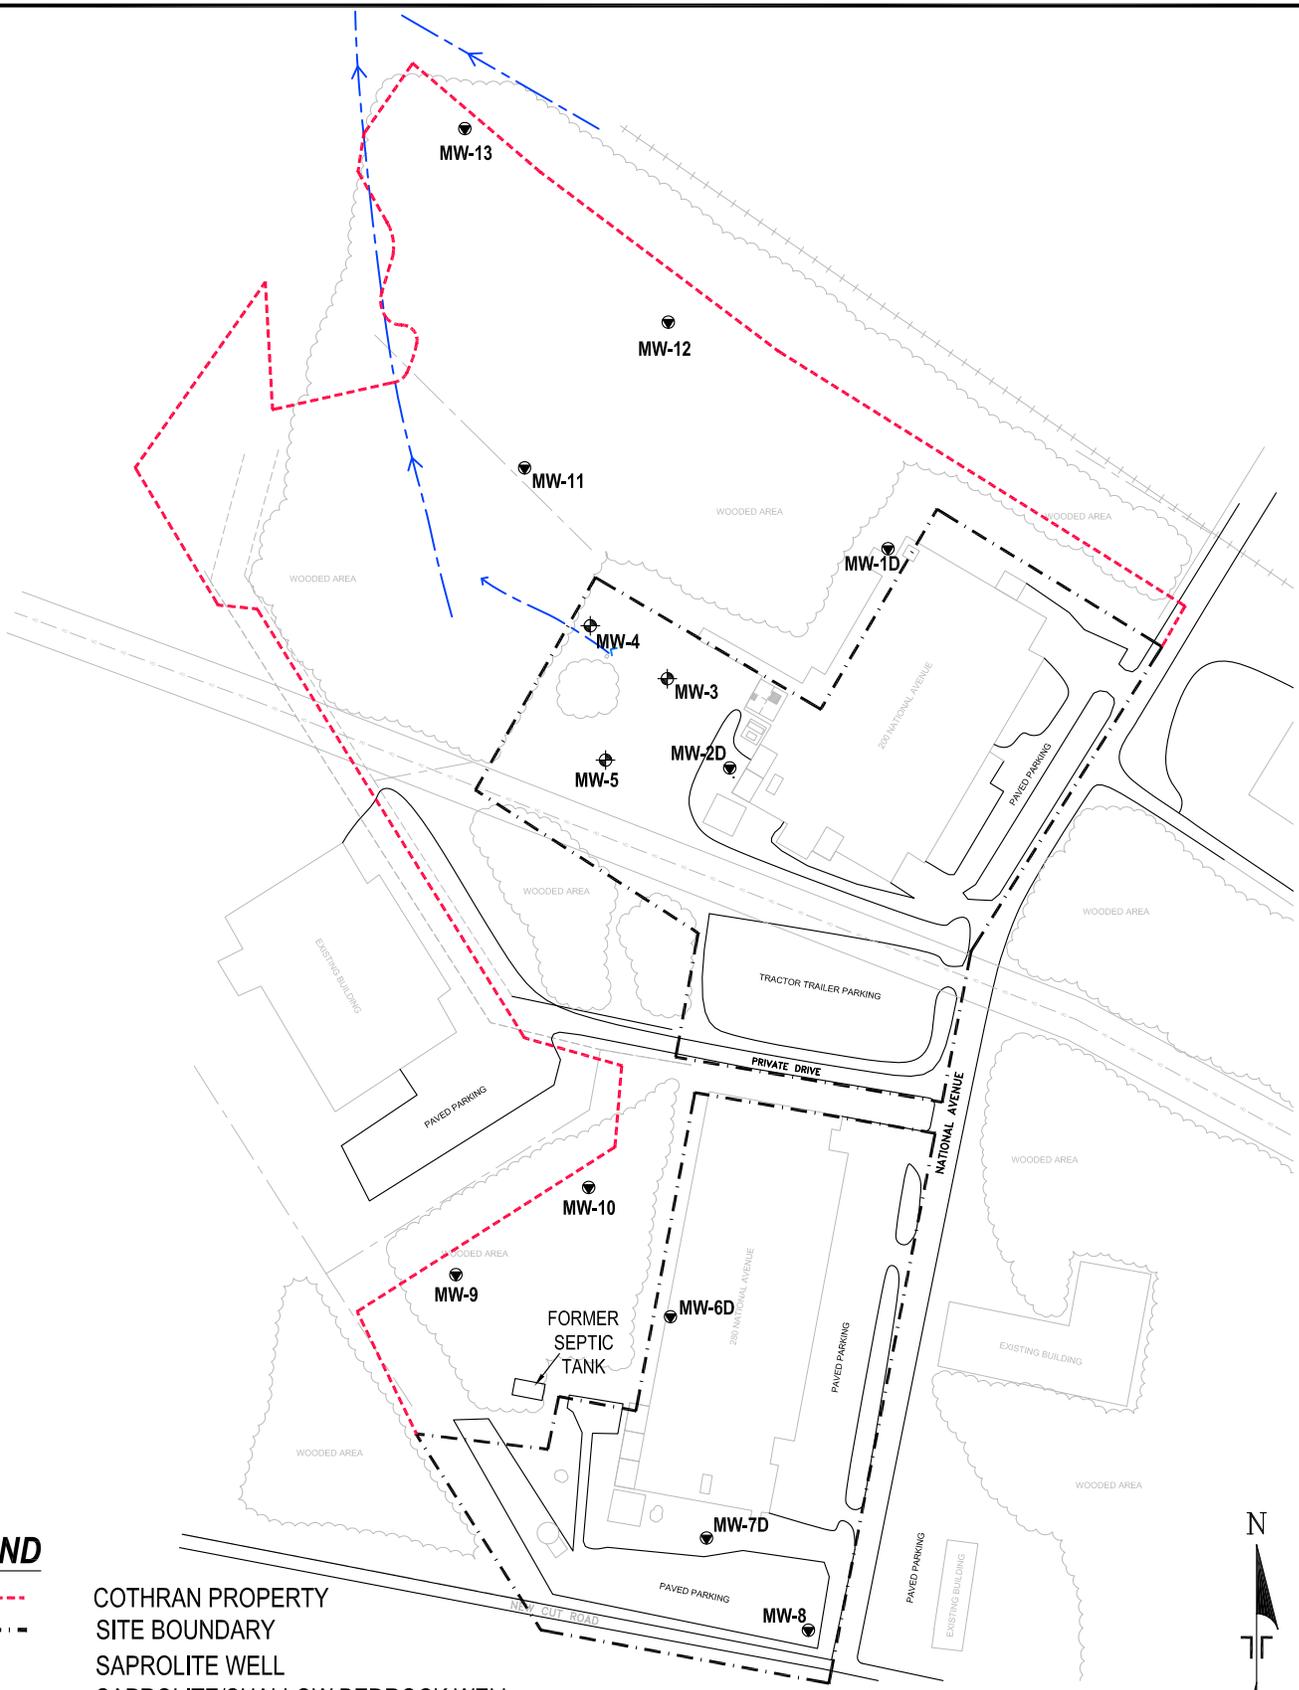
**2**

- - - - - COTHRAN PROPERTY
- SITE BOUNDARY
- SAPROLITE WELL
- SAPROLITE/SHALLOW BEDROCK WELL
- - - - - STREAM

observed in the groundwater screening samples. Based on the Phase I RI screening results, seven permanent monitoring wells (MW-1D, -2D, -3, -4, -5, -6D, and -7D) were installed on the Castlebridge property in August 2009 to evaluate the on-site horizontal extent of the chlorinated hydrocarbon plume in the saprolite and shallow bedrock aquifer. Monitoring wells were not installed off of the property at that time due to site physical constraints and access issues. Based on the distribution of the detected PCE/TCE, the source of the groundwater contamination was related to the previous use of drycleaning fluids at the 200 National Avenue building and, to a lesser degree, at the 280 National Avenue building.

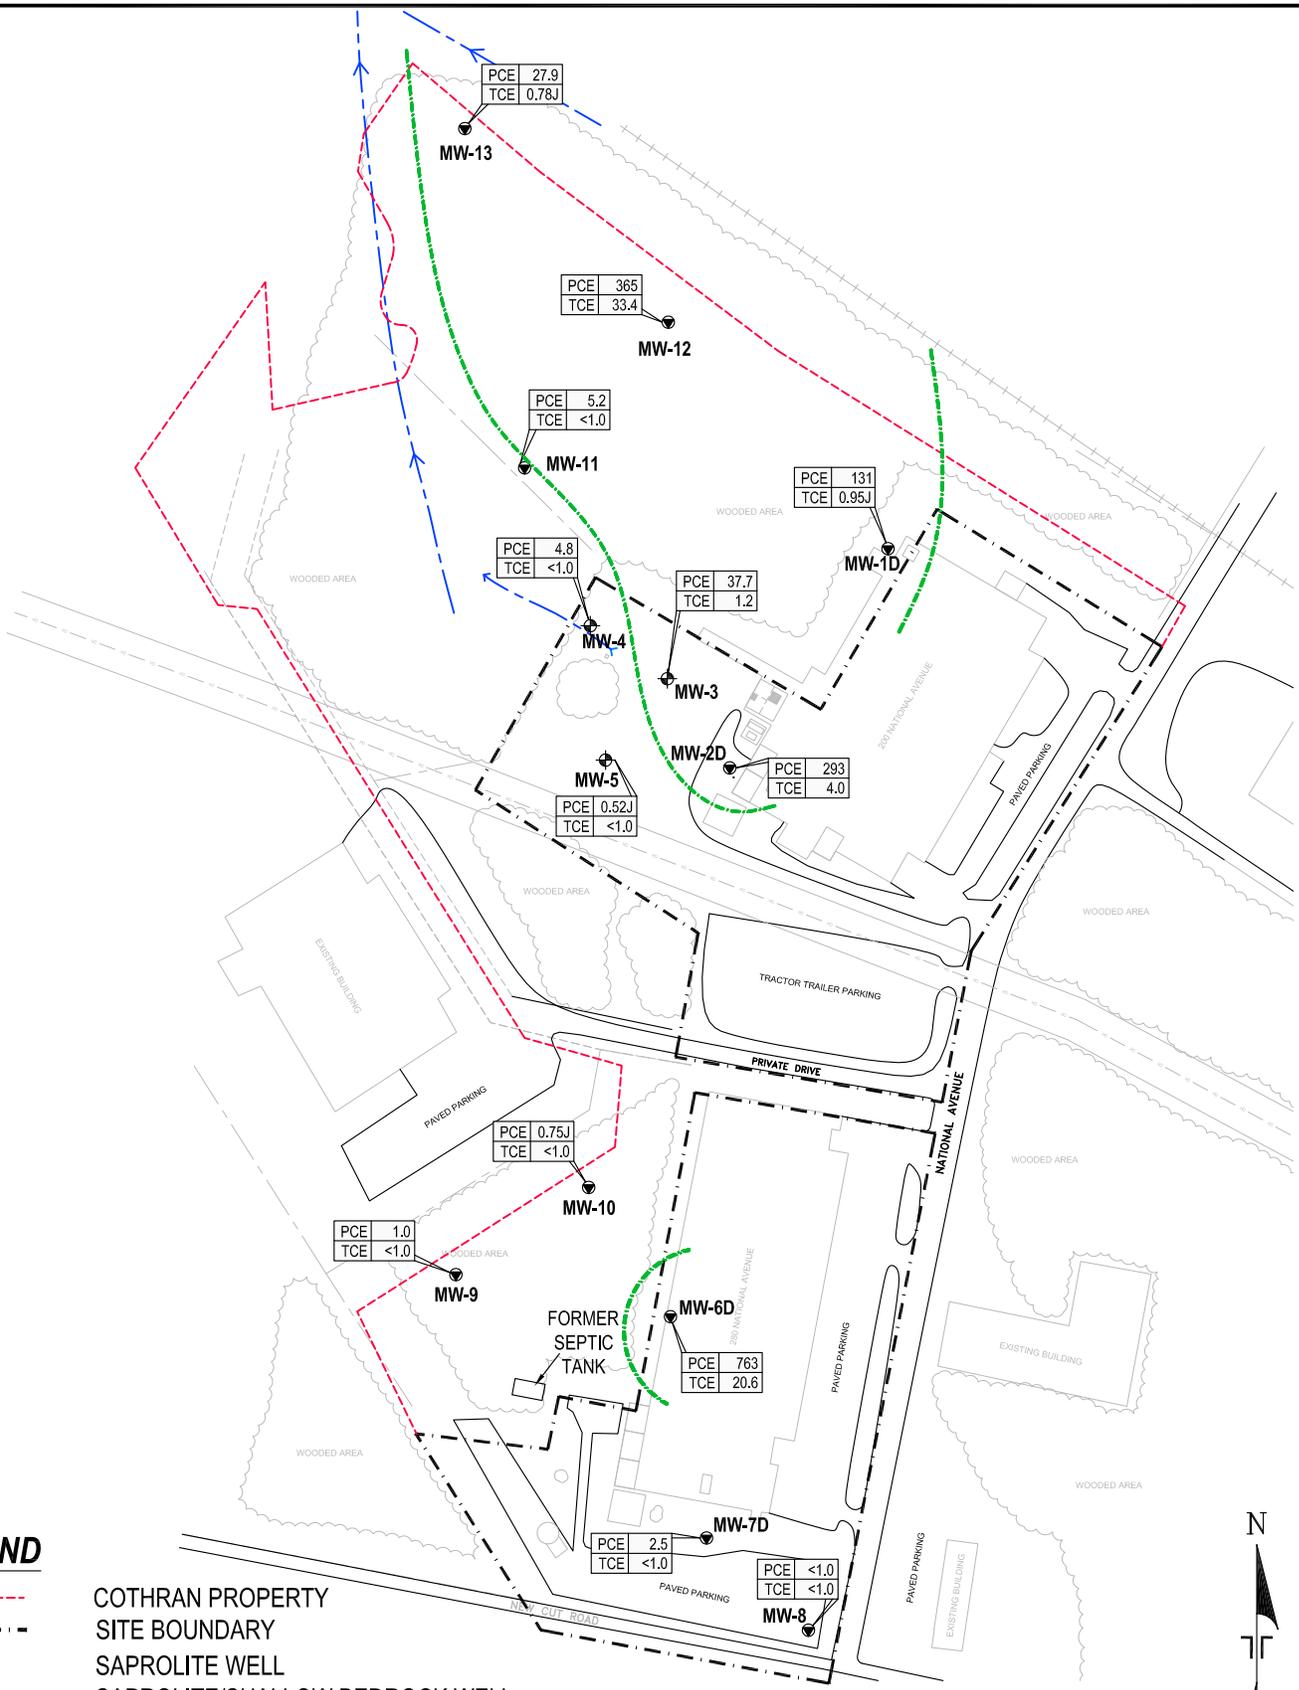
**3**

- - - - - COTHRAN PROPERTY
- SITE BOUNDARY
- SAPROLITE WELL
- SAPROLITE/SHALLOW BEDROCK WELL
- PCE TETRACHLOROETHENE, µG/L
- TCE TRICHLOROETHENE, µG/L
- - - - - <5mg/L CVOC MCL

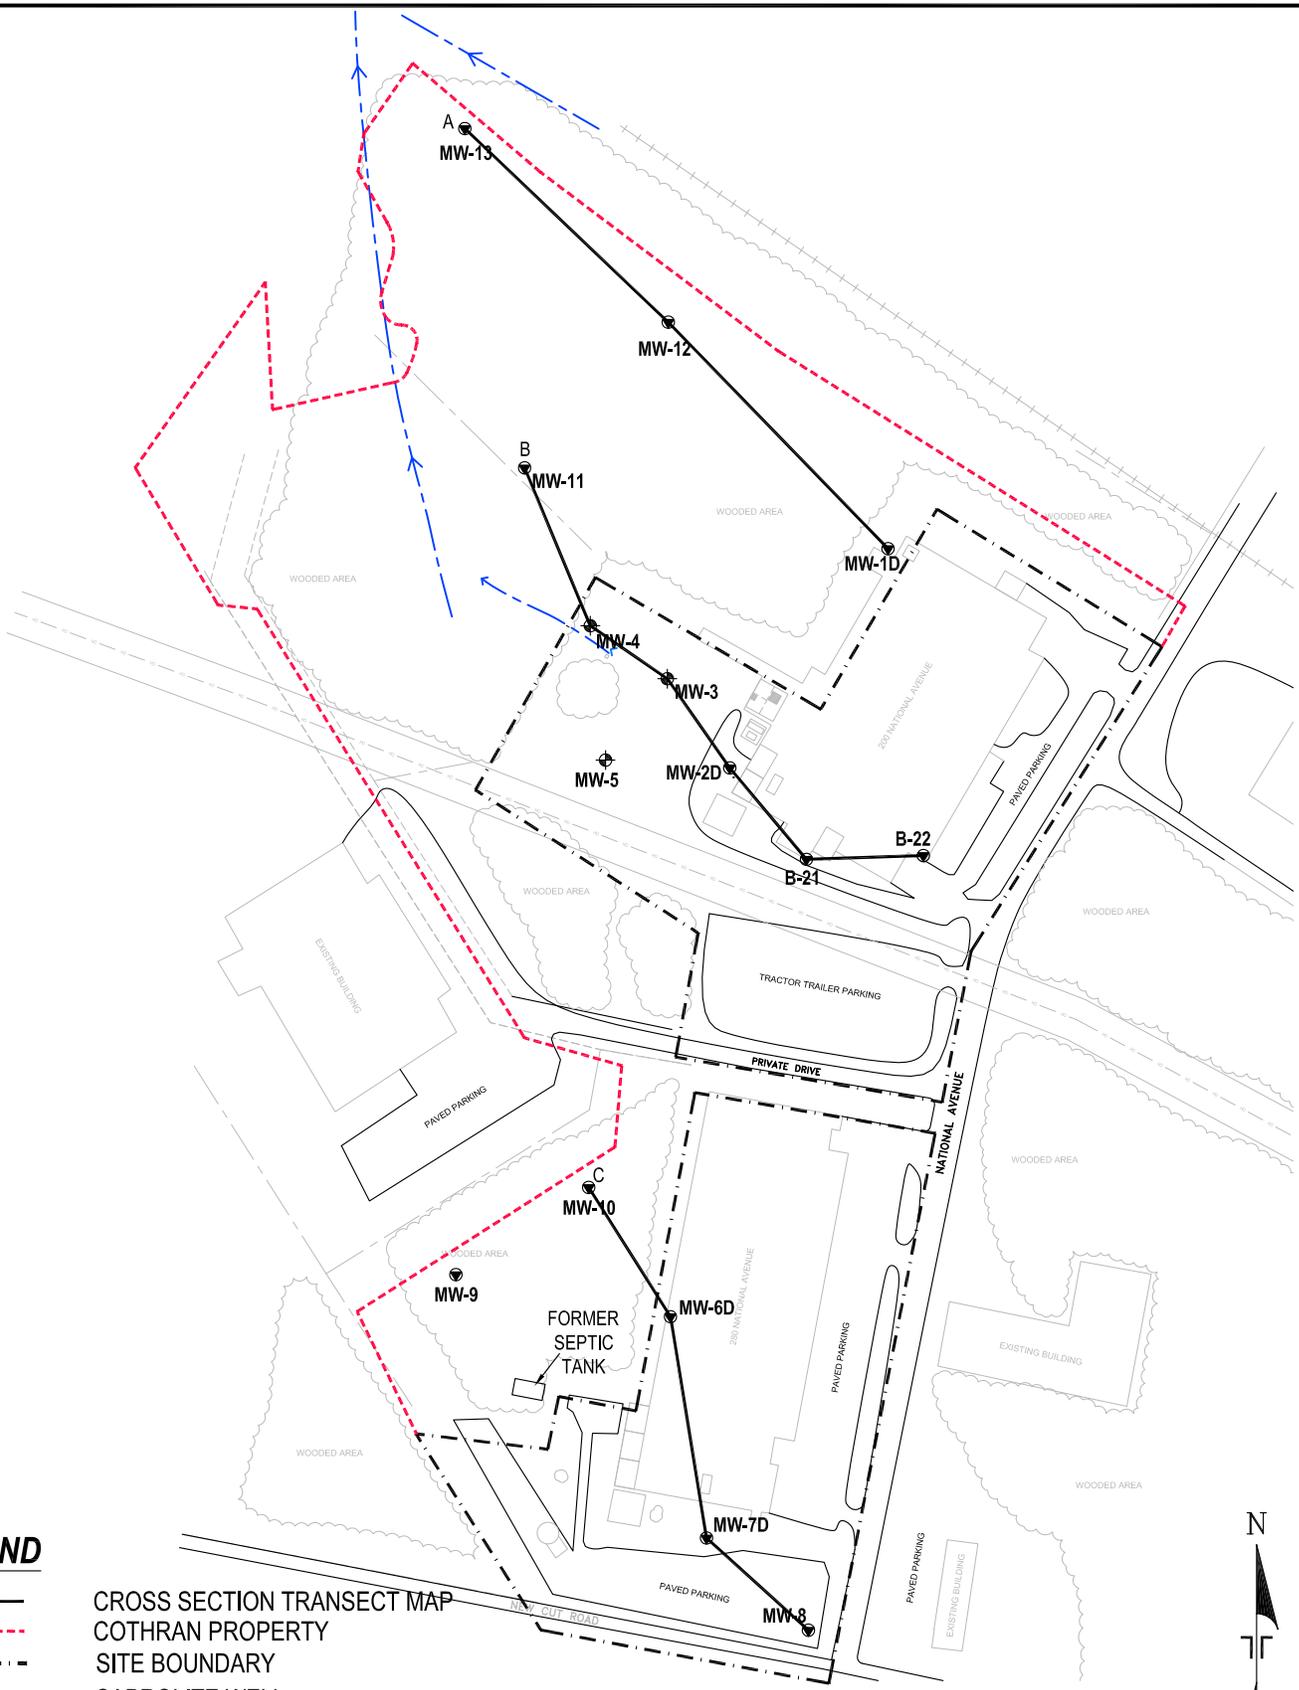
**5**

- CROSS SECTION TRANSECT MAP
- COTHRAN PROPERTY
- SITE BOUNDARY
- SAPROLITE WELL
- SAPROLITE/SHALLOW BEDROCK WELL
- STREAM

The geology of the Piedmont Physiographic Province consists of three zones which include, in descending order, the regolith zone, the transition zone between the bedrock and regolith, and the bedrock zone. The regolith zone consists primarily of saprolite, the unconsolidated weathering product of the underlying parent rock that retains the relic structure of the parent rock. The transition zone consists of partially weathered bedrock (PWR) and primarily of rock fragments, boulder size rocks, and fractured bedrock. The bedrock zone consists of crystalline igneous and metamorphic rocks composed of fine grained granitic gneiss. Soil samples of the saprolite collected during the Phase I RI were described as predominantly micaceous sandy silt to silty sand. The thickness of the saprolite, as defined by GeoProbe refusal during the Phase I RI and hollow stem auger (HSA) refusal during well installation, is highly variable across the property from 3 feet below ground surface (bgs) along the eastern site boundary with National Avenue (B-22) to an average of 45 feet bgs towards the western property boundary (see **Exhibit 4** for soil boring locations). A thin transition zone of partially weathered bedrock was generally encountered between 45 to 50 feet bgs along the center of the property. The bedrock interface, as defined by refusal to hollow stem augers and confirmed with rock cores during the well installation, was encountered from 50 feet bgs at the southern property boundary along New Cut Road to 45 feet near the northern property boundary with the Norfolk Southern railroad. Deeper bedrock, to a depth of 65 feet bgs, was encountered in a relic draw along the western property boundary trending south-southeast to north-northwest towards the ephemeral stream on the Cothran property. Using data obtained from previous Phase I RI and subsequent groundwater assessments, geologic cross sections were prepared for the site and are included in **Exhibits 5, 5A, 5B, and 5C**.

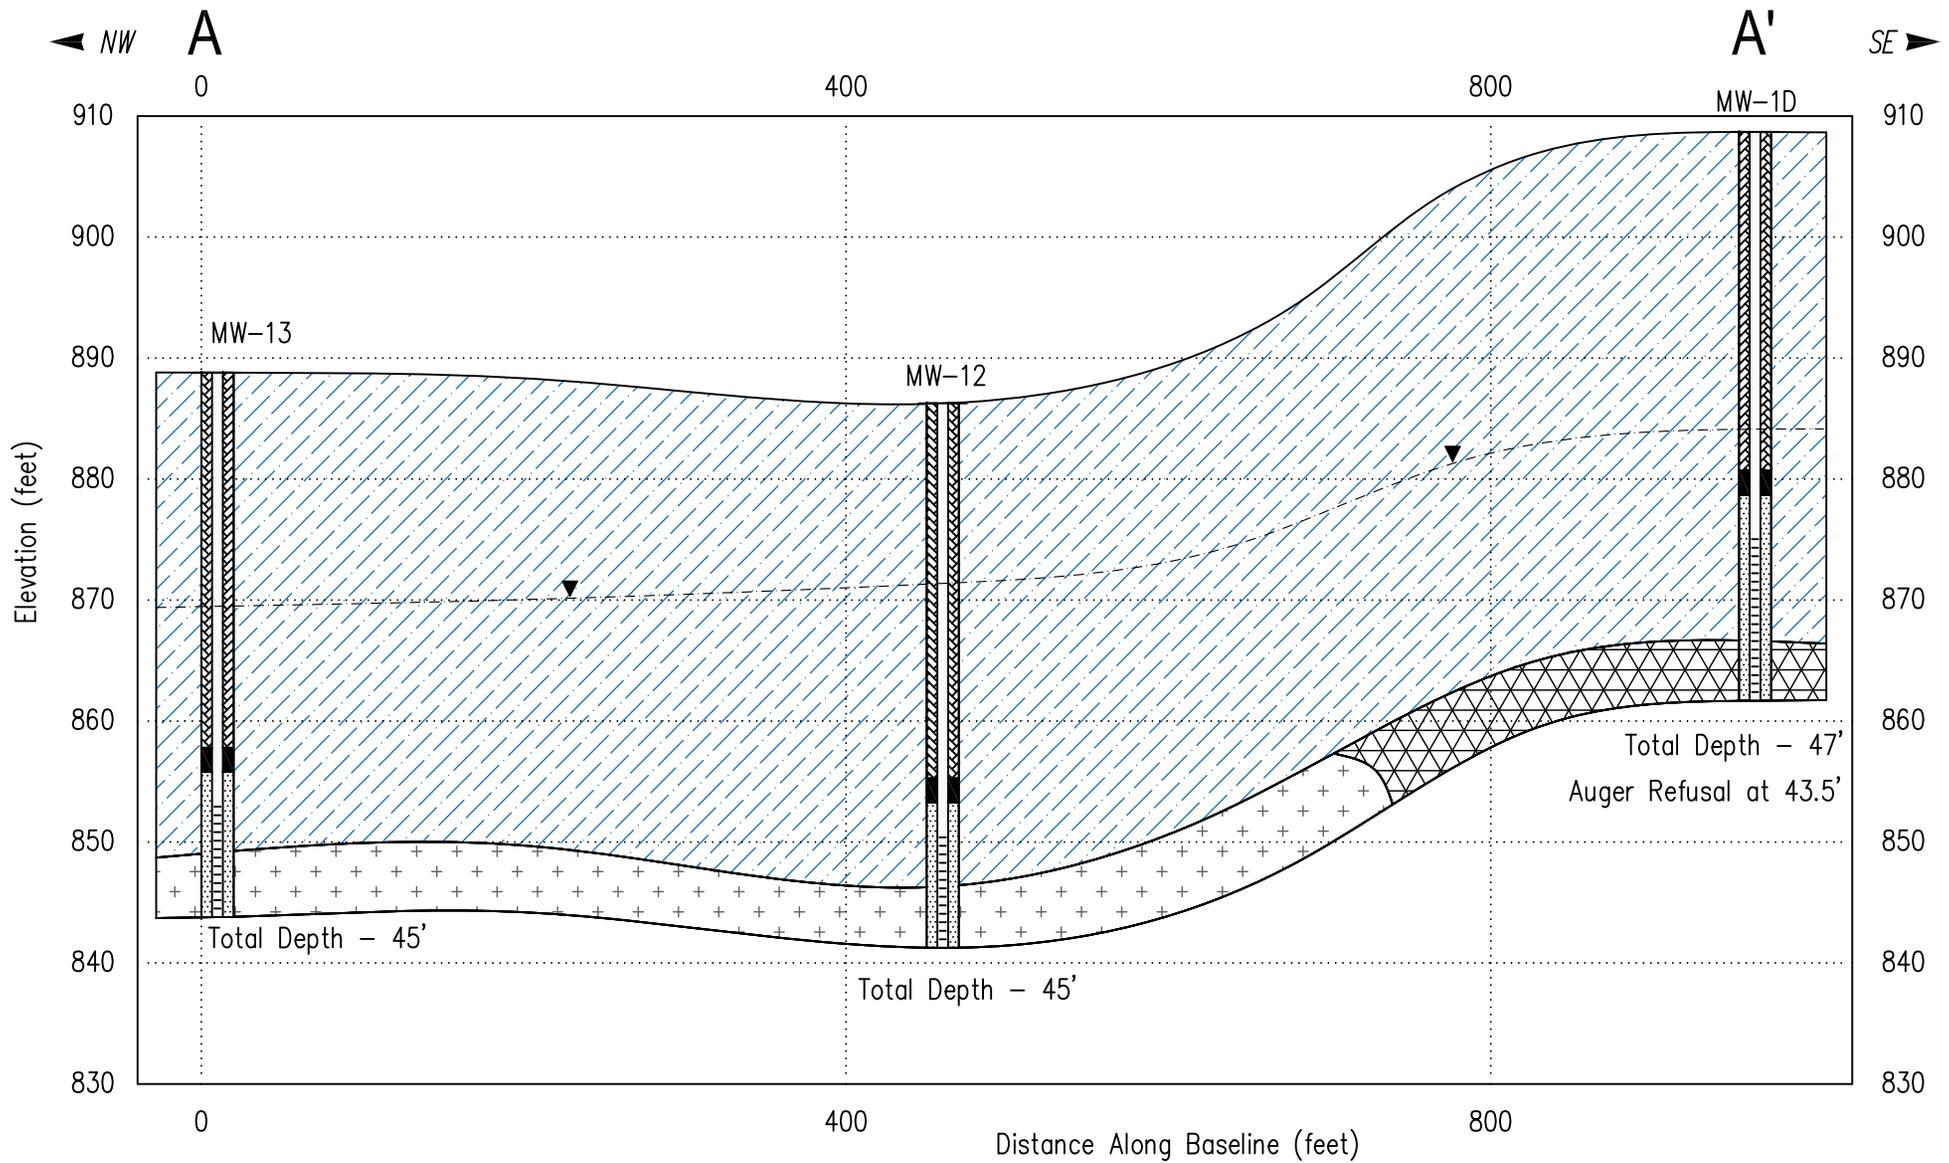
MONITORING WELL CONSTRUCTION DETAILS EXAGGERATED FOR DETAIL

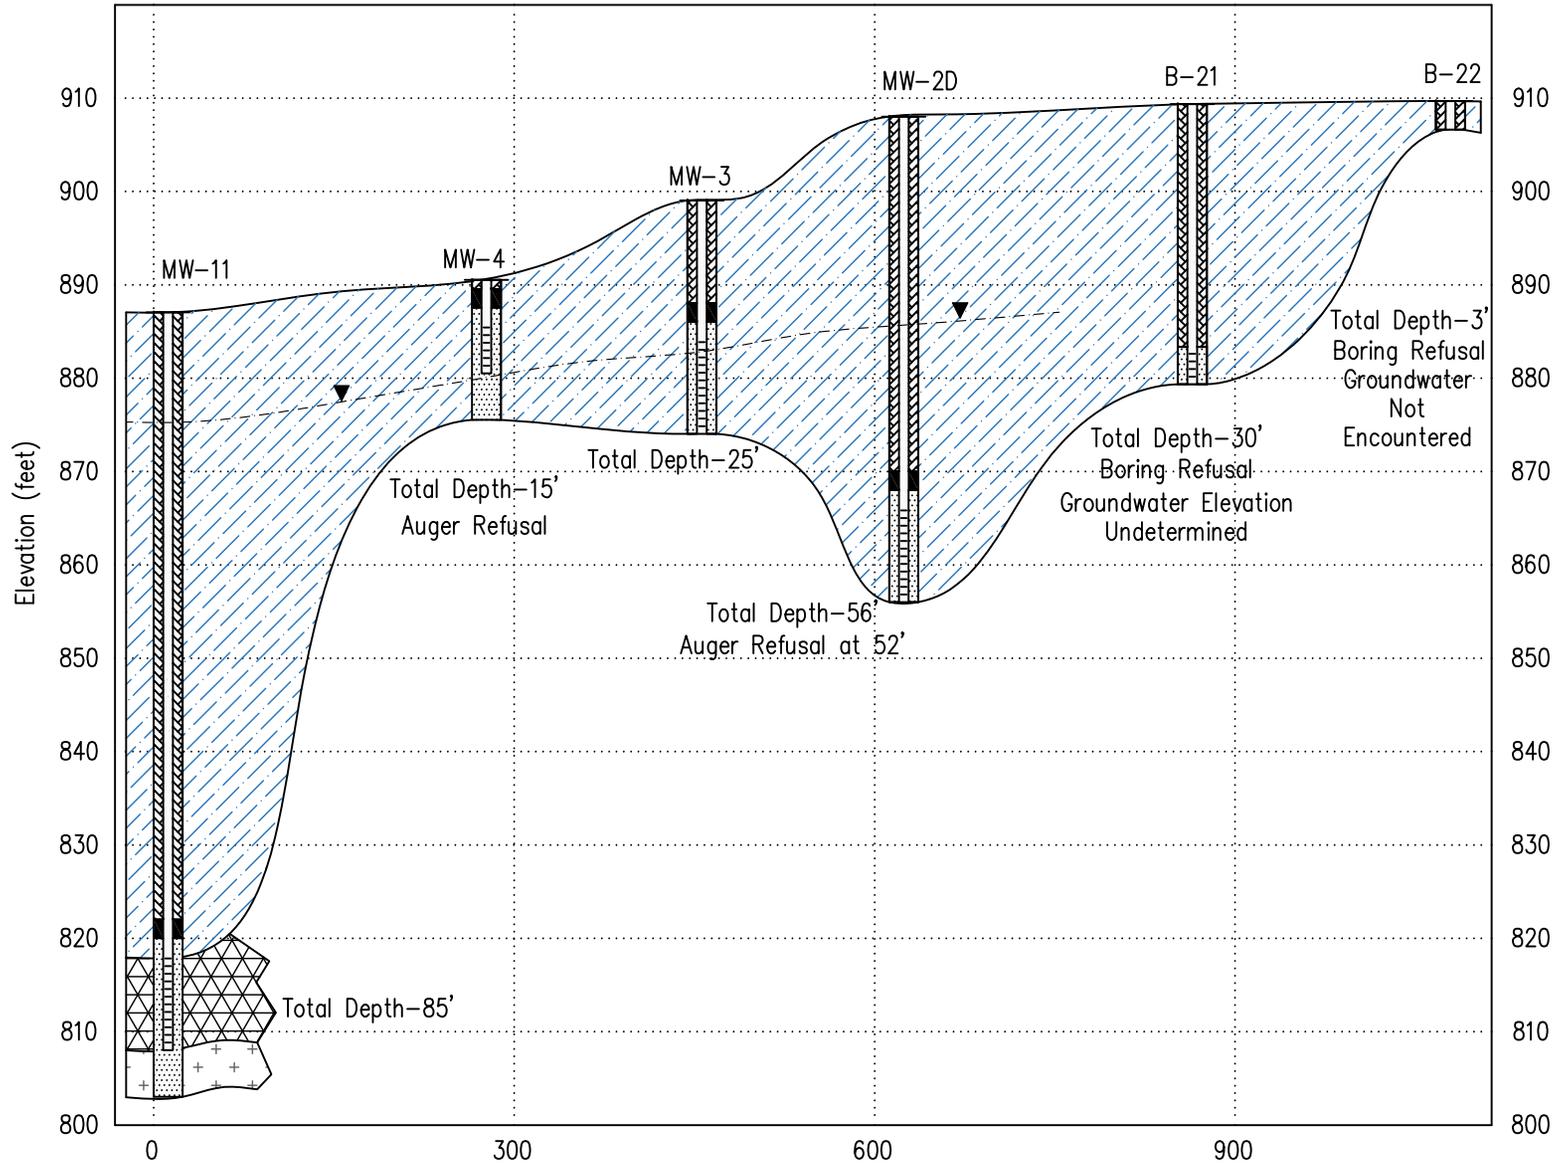
EXHIBIT  
**5B**

- SAPROLITE
- WELLSCREEN AND ARTIFICIAL FILTER
- PARTIALLY WEATHERED ROCK
- BEDROCK
- APPROXIMATE GROUNDWATER ELEVATION

MONITORING WELL CONSTRUCTION DETAILS EXAGGERATED FOR DETAIL

**GEOLOGIC CROSS SECTION B-B'**  
REMEDIAL ALTERNATIVES EVALUATION  
CASTLEBRIDGE PROPERTIES, LLC PROPERTY  
200 AND 280 NATIONAL AVENUE  
SPARTANBURG, SPARTANBURG COUNTY, SC

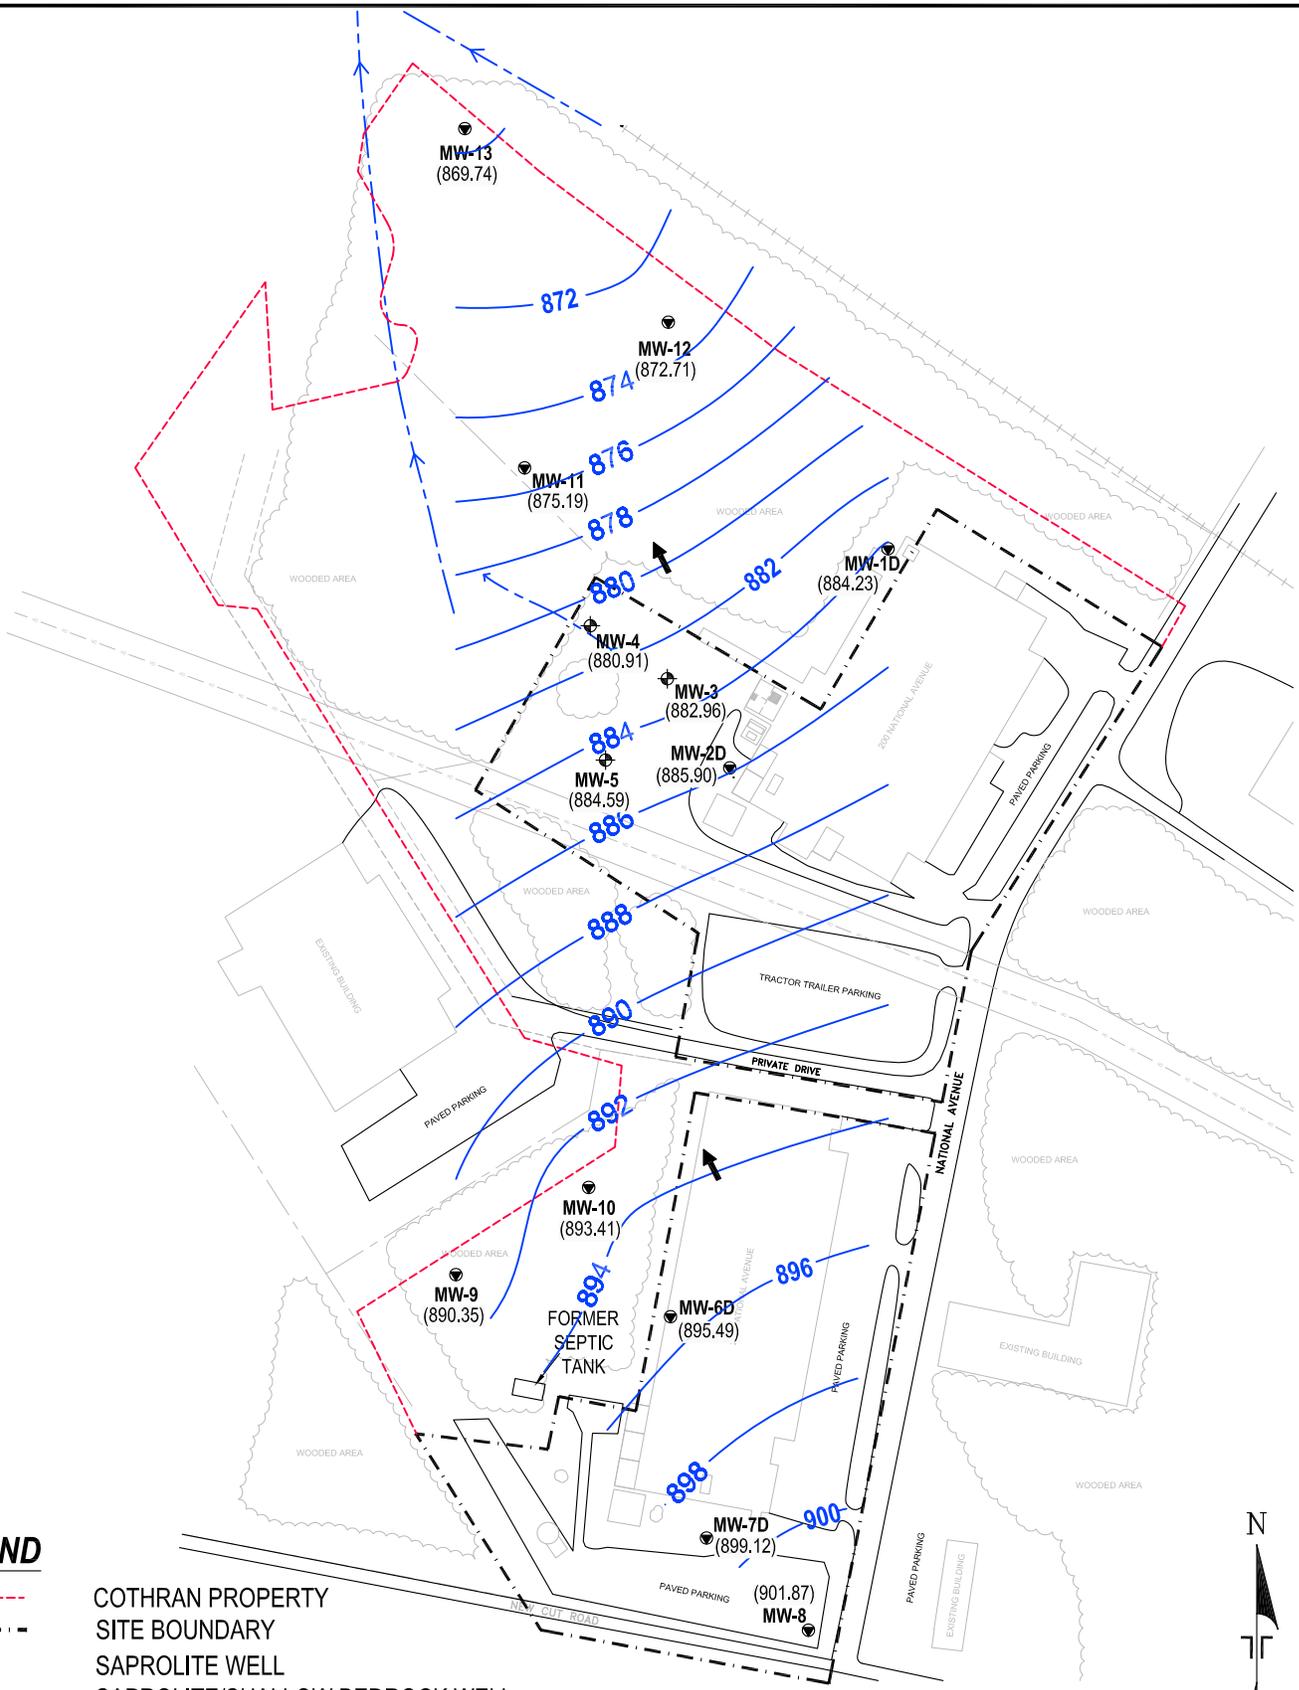
- - - COTHRAN PROPERTY
- - - SITE BOUNDARY
- SAPROLITE WELL
- SAPROLITE/SHALLOW BEDROCK WELL
- (884.59) GROUNDWATER ELEVATION, IN FEET
- 884— GROUNDWATER CONTOUR, IN FEET
- APPARENT GROUNDWATER FLOW DIRECTION
- - - STREAM

Groundwater in the Piedmont Physiographic Province typically occurs under unconfined conditions within the saprolite and underlying fractured bedrock. Groundwater flow directions are a subtle reflection of the local topography from areas of topographic highs to areas of topographic lows. Local recharge of the shallow aquifer occurs by the direct infiltration of precipitation. Some quantity of groundwater in the regolith zone also migrates downward to recharge the transition zone and the underlying bedrock. Groundwater occurrence and migration in the bedrock is controlled by fractures. Although, very little to no fracturing was observed in rock cores obtained during the installation of the wells MW-1D, -2D, -6D, and -7D.

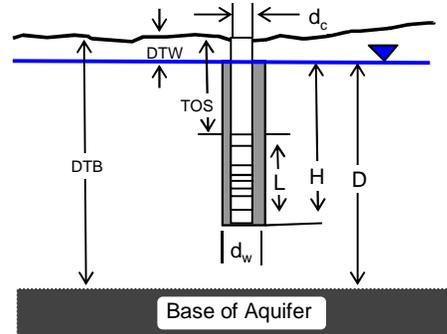
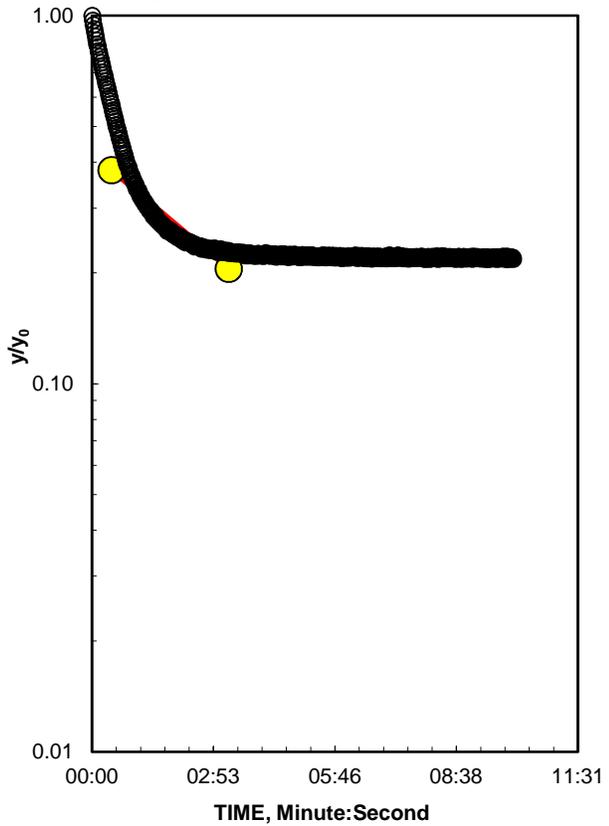
Construction:	
Casing dia. ( $d_c$ )	2 Inch
Annulus dia. ( $d_w$ )	8.25 Inch
Screen Length (L)	15 Feet
Depths to:	
water level (DTW)	17.46 Feet (TOC)
top of screen (TOS)	32 Feet (BGS)
Base of Aquifer (DTB)	60 Feet
Annular Fill:	
across screen --	Coarse Sand
above screen --	Bentonite
Aquifer Material -- Silt, Loess

Adjust slope of line to estimate K

$L_{wetted}$	15 Feet
D =	42.54 Feet
H =	29.54 Feet
$L/r_w$	43.64
$y_0$ -DISPLACEMENT =	1.62 Feet
$y_0$ -SLUG =	1.69 Feet
From look-up table using $L/r_w$	
Partial penetrate A =	2.938
B =	0.473
$\ln(Re/r_w)$ =	2.827
Re =	5.81 Feet
Slope =	$0.001605 \log_{10}/\text{sec}$
$t_{90\%}$ recovery =	623 sec

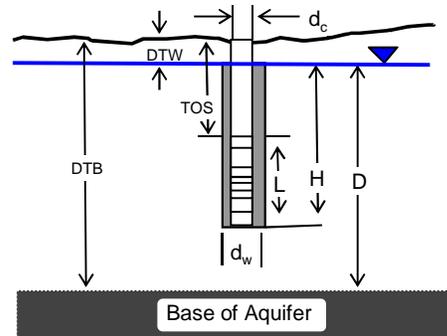
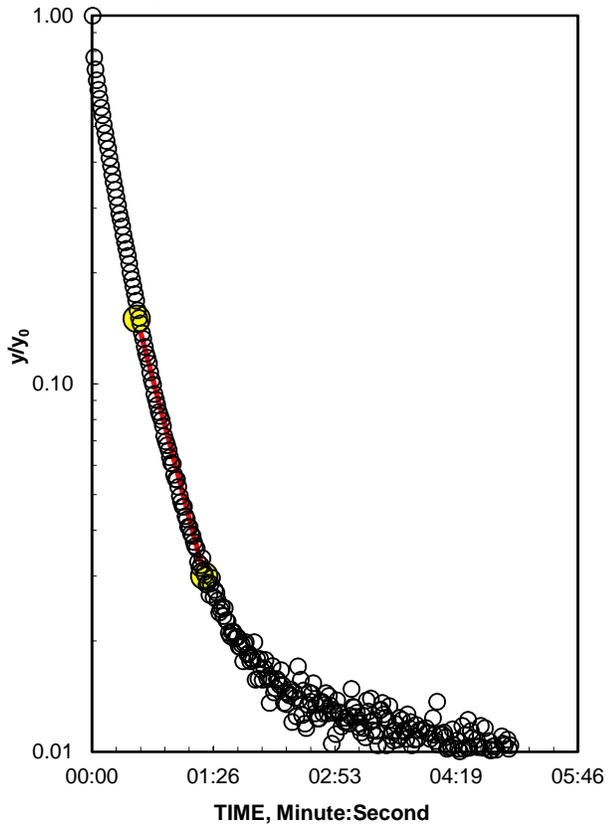
Construction:	
Casing dia. ( $d_c$ )	2 Inch
Annulus dia. ( $d_w$ )	8.25 Inch
Screen Length (L)	10 Feet
Depths to:	
water level (DTW)	17.46 Feet (TOC)
top of screen (TOS)	15 Feet (BGS)
Base of Aquifer (DTB)	60 Feet
Annular Fill:	
across screen --	Coarse Sand
above screen --	Bentonite
Aquifer Material -- Fine Sand

$L_{wetted}$	7.54 Feet
D =	42.54 Feet
H =	7.54 Feet
$L/r_w$	21.93
$y_0$ -DISPLACEMENT =	1.84 Feet
$y_0$ -SLUG =	1.69 Feet
From look-up table using $L/r_w$	
Partial penetrate A =	2.269
B =	0.361
$\ln(Re/r_w)$ =	1.866
Re =	2.22 Feet
Slope =	$0.014562 \log_{10}/\text{sec}$
$t_{90\%}$ recovery =	69 sec

**K = 2.5 Feet/Day**

Adjust slope of line to estimate K

Bower and Rice analysis of slug test, WRR 1976

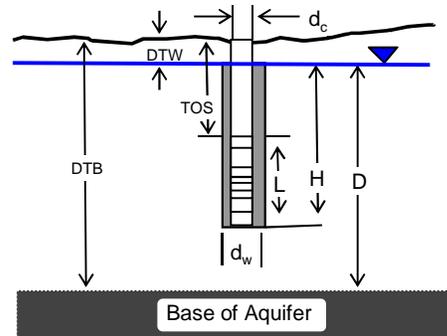
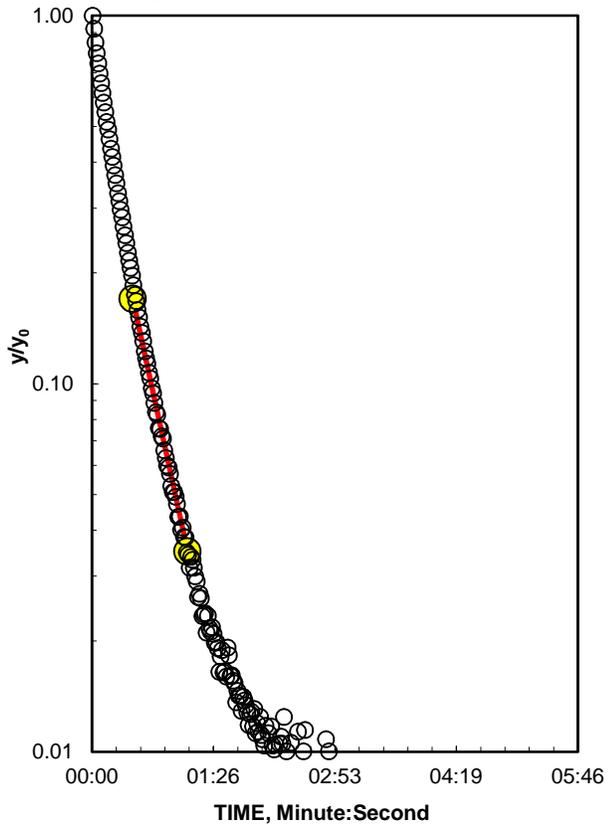
Construction:	
Casing dia. ( $d_c$ )	2 Inch
Annulus dia. ( $d_w$ )	8.25 Inch
Screen Length (L)	15 Feet
Depths to:	
water level (DTW)	28.42 Feet (TOC)
top of screen (TOS)	35 Feet (BGS)
Base of Aquifer (DTB)	60 Feet
Annular Fill:	
across screen --	Coarse Sand
above screen --	Bentonite
Aquifer Material -- Fine Sand

$L_{wetted}$	15 Feet
D =	31.58 Feet
H =	21.58 Feet
$L/r_w$	43.64
$y_0$ -DISPLACEMENT =	1.67 Feet
$y_0$ -SLUG =	1.69 Feet
From look-up table using $L/r_w$	
Partial penetrate A =	2.938
B =	0.473
$\ln(Re/r_w)$ =	2.705
Re =	5.14 Feet
Slope =	0.0176 $\log_{10}/\text{sec}$
$t_{90\%}$ recovery =	57 sec

**K = 2.2 Feet/Day**

Adjust slope of line to estimate K

Bower and Rice analysis of slug test, WRR 1976
